**SPILLWAY TESTS CONFIRM
MODEL-PROTOTYPE CONFORMANCE**

By A. J. Peterka

Engineering Monograph

No. 16

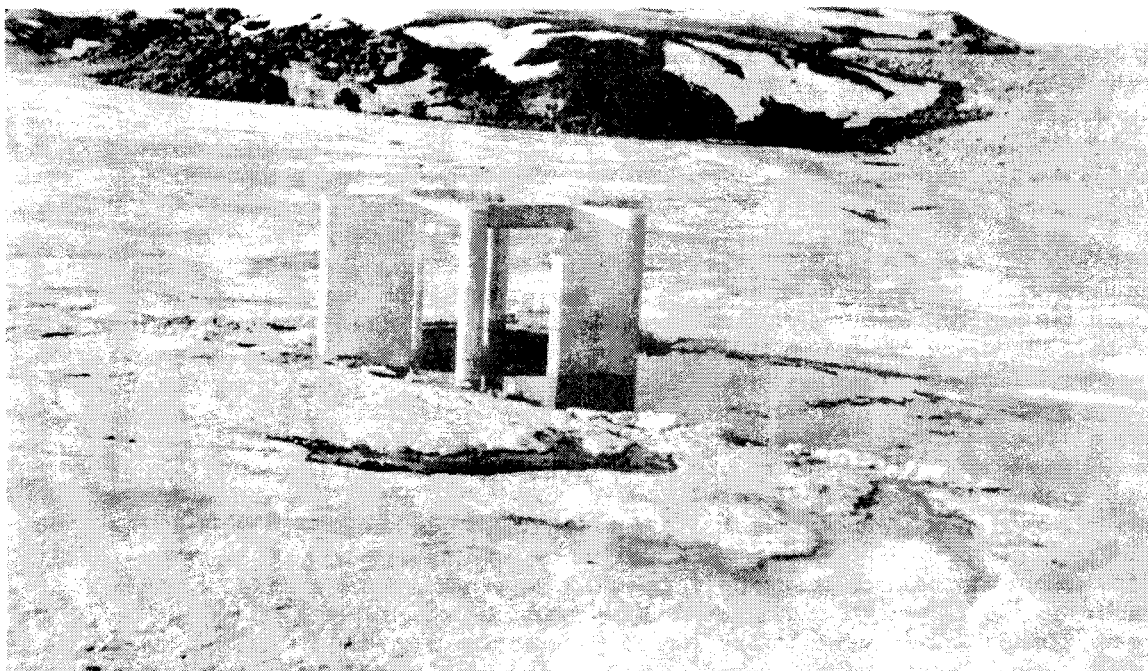
A--On April 16, 1950, the reservoir had risen to the spillway crest, elevation 2064.5. The upstream face of the dam is at the right.

FIGURE 14--Performance of spillway and outlet works at Heart Butte Dam.

On April 16, 1950, the reservoir had risen to the spillway crest elevation 2064.5. Ice covered most of the reservoir area, but there was some open water close to the spillway, see figure 14A. Before flow started over the spillway, the tunnel was inspected and ice which had formed around the outlet works gate was removed, see figure 14B. By April 17, 1950, the reservoir had risen sufficiently to submerge the spillway and provide a head of 9.3 feet on the crest, corresponding to a discharge of 3,250 cfs, see figure 15. Sometime during the night the reservoir elevation had passed through the critical region where the flow changes from free to submerged. Some ice had been discharged through the spillway, but it had caused no apparent difficulty. On April 18, the piers were completely covered and the reservoir was covered with ice, see figure 16A, which appeared to be about 12 inches thick. A small amount of trash had collected over the spillway and slight movement of the trash was the only evidence that the spillway existed. The

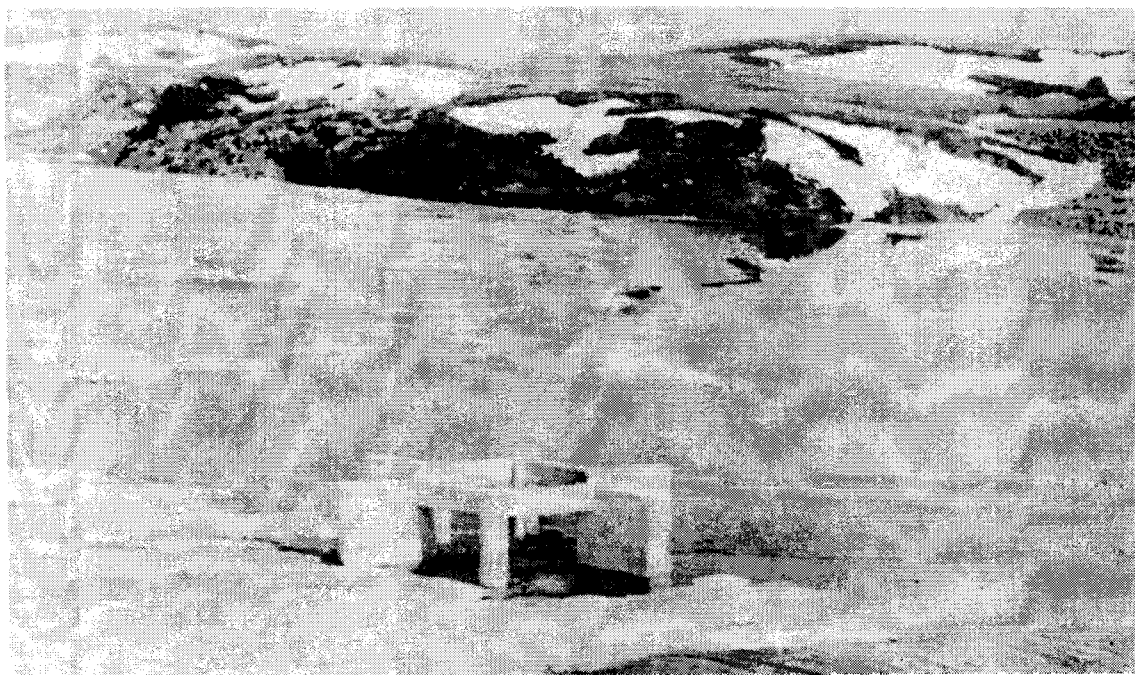
FIGURE 15--On April 17 the reservoir had risen to elevation 2073.8, submerging the spillway crest to a depth of 9.3 feet at a discharge of 3,250 cfs.

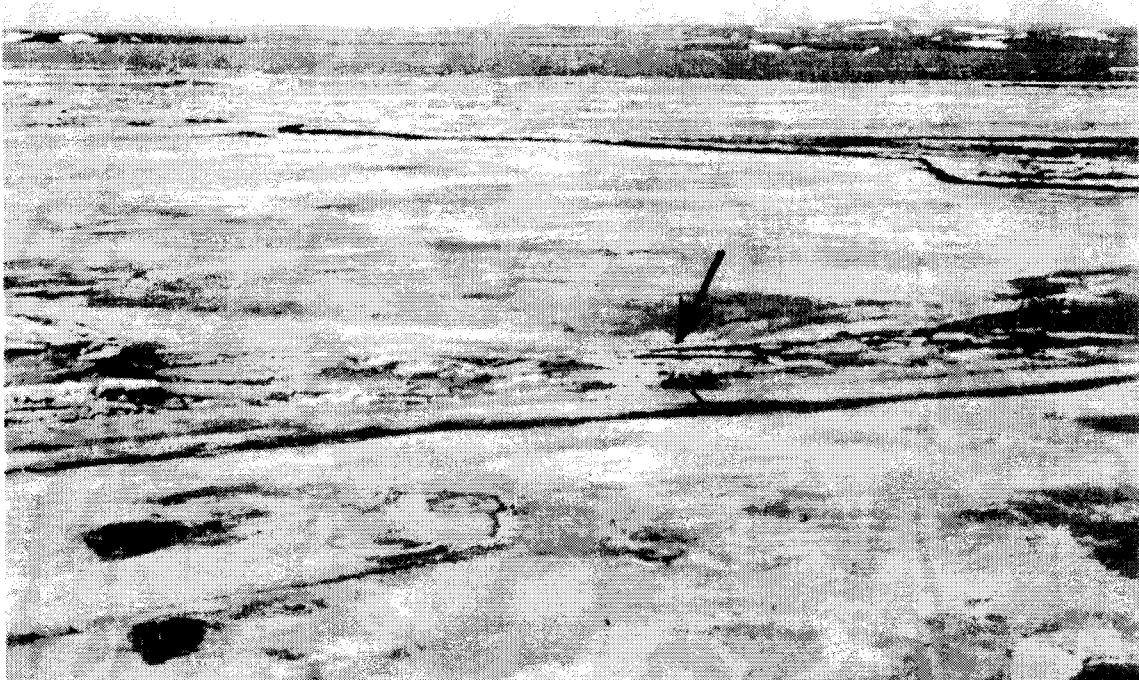
A--On April 18 the reservoir elevation was 2080.2, the head on the crest 15.7 feet, piers were submerged 1.7 feet, and the discharge was 3,650 cfs. Arrow indicates the spillway location.

FIGURE 16--Operation of Heart Butte spillway with piers submerged.

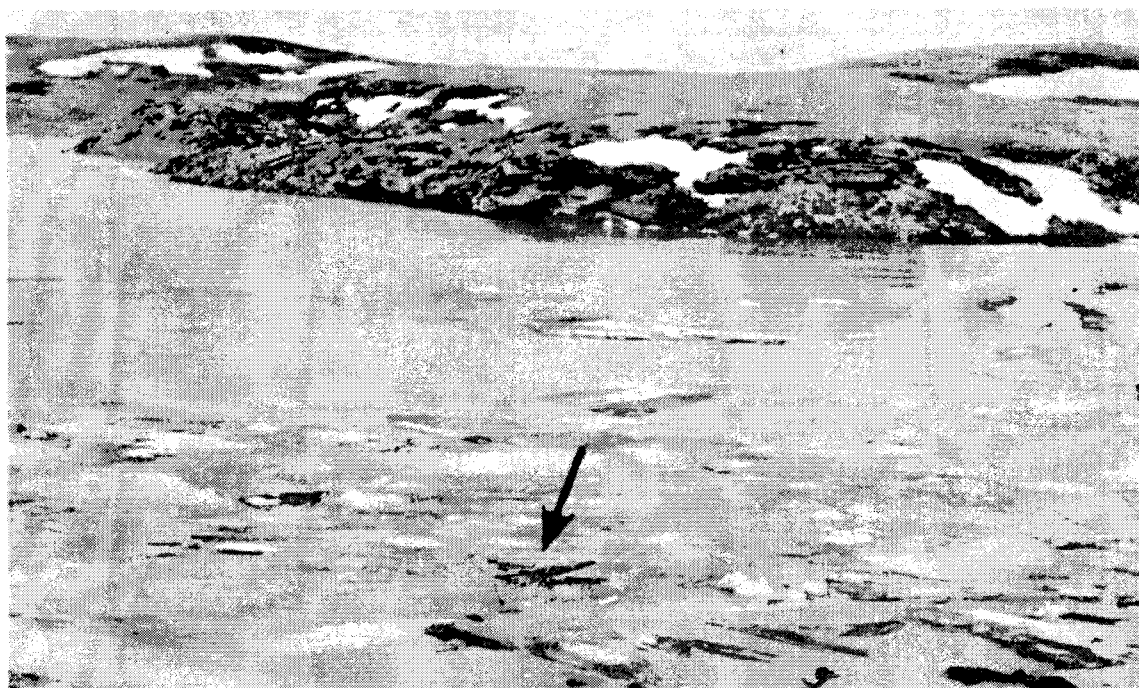
B--By April 21 the reservoir had receded slightly, but water still stood a foot above the tops of the piers. Spillway at arrow.

reservoir continued to rise throughout April 19, but on April 20 it started to recede. On April 21 the reservoir was still a foot or so above the piers, see figure 16B. The ice was breaking up fast and the wind was shifting it around the spillway area. Regardless of whether ice or water was over the spillway entrance, the operation was satisfactory, with no evidence of serious vortex action.

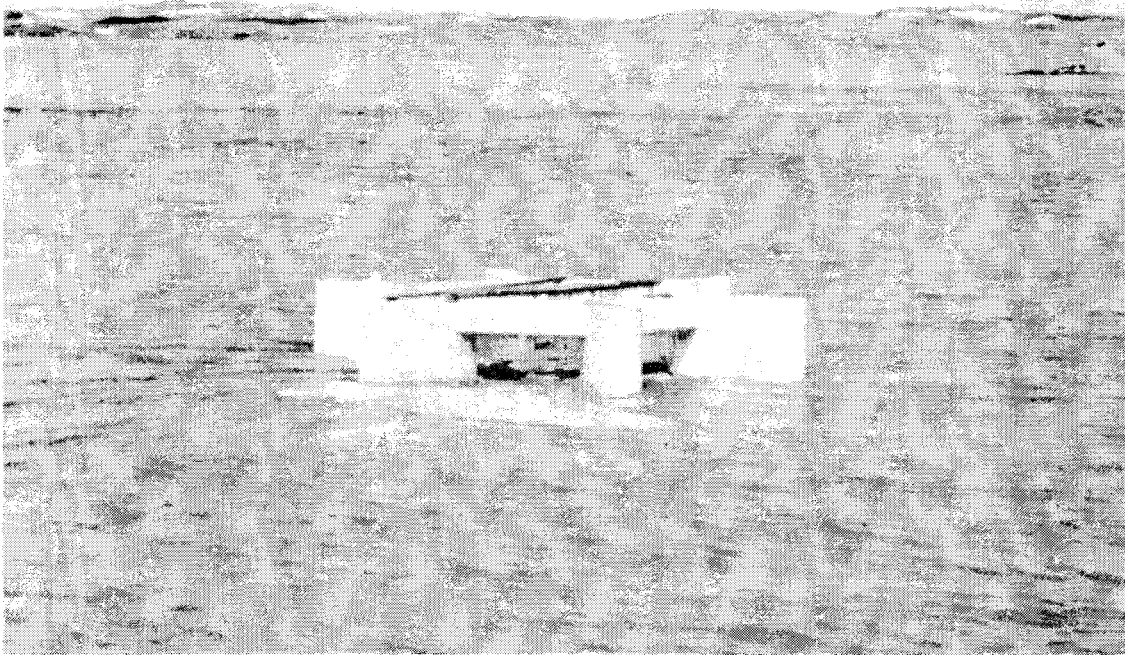
FIGURE 17--Reservoir elevation had been reduced to 2074.0 April 26. Ice hid any disturbance in the morning glory. Discharge was 3,260 cfs.

On April 26, with the reservoir at elevation 2074 and the piers again visible, operation was also satisfactory, see figure 17.

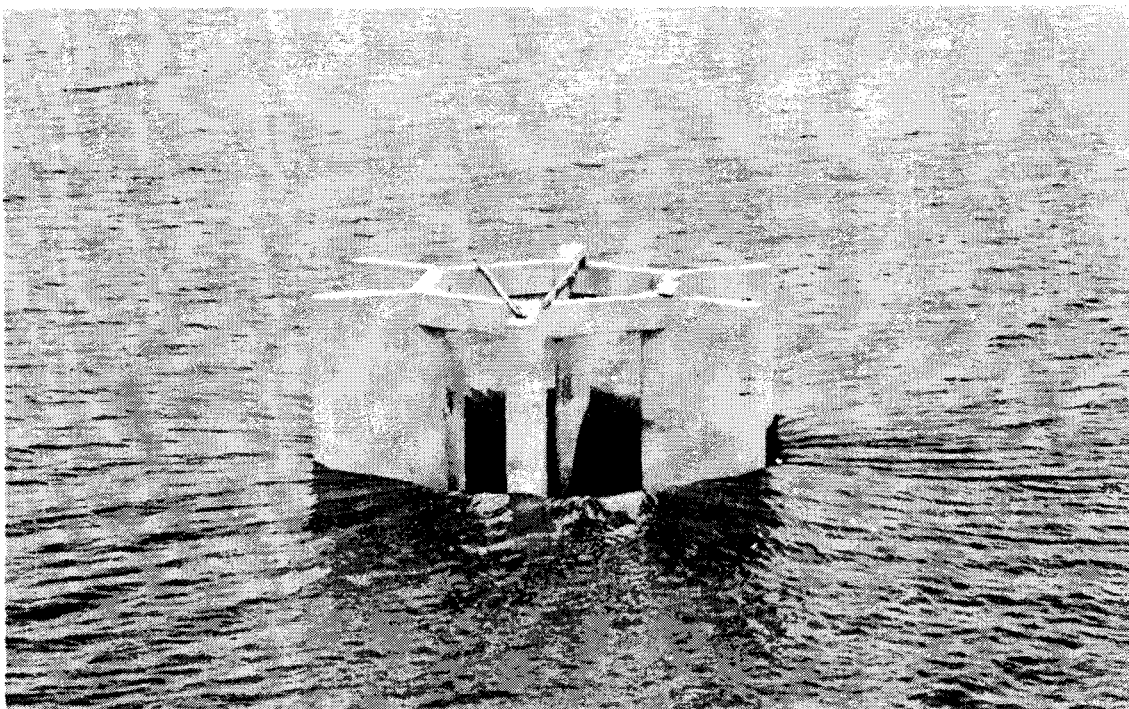
FIGURE 19--With the reservoir elevation at 2068.6 on April 30, the spillway was discharging freely at a rate of 1,600 cfs.

The spillway was discharging freely on April 30, (1,600 cfs) with reservoir elevation 2068.6, see figure 19. No spray emerged from the glory hole at this or lower heads as has occurred on some other glory hole spillways.

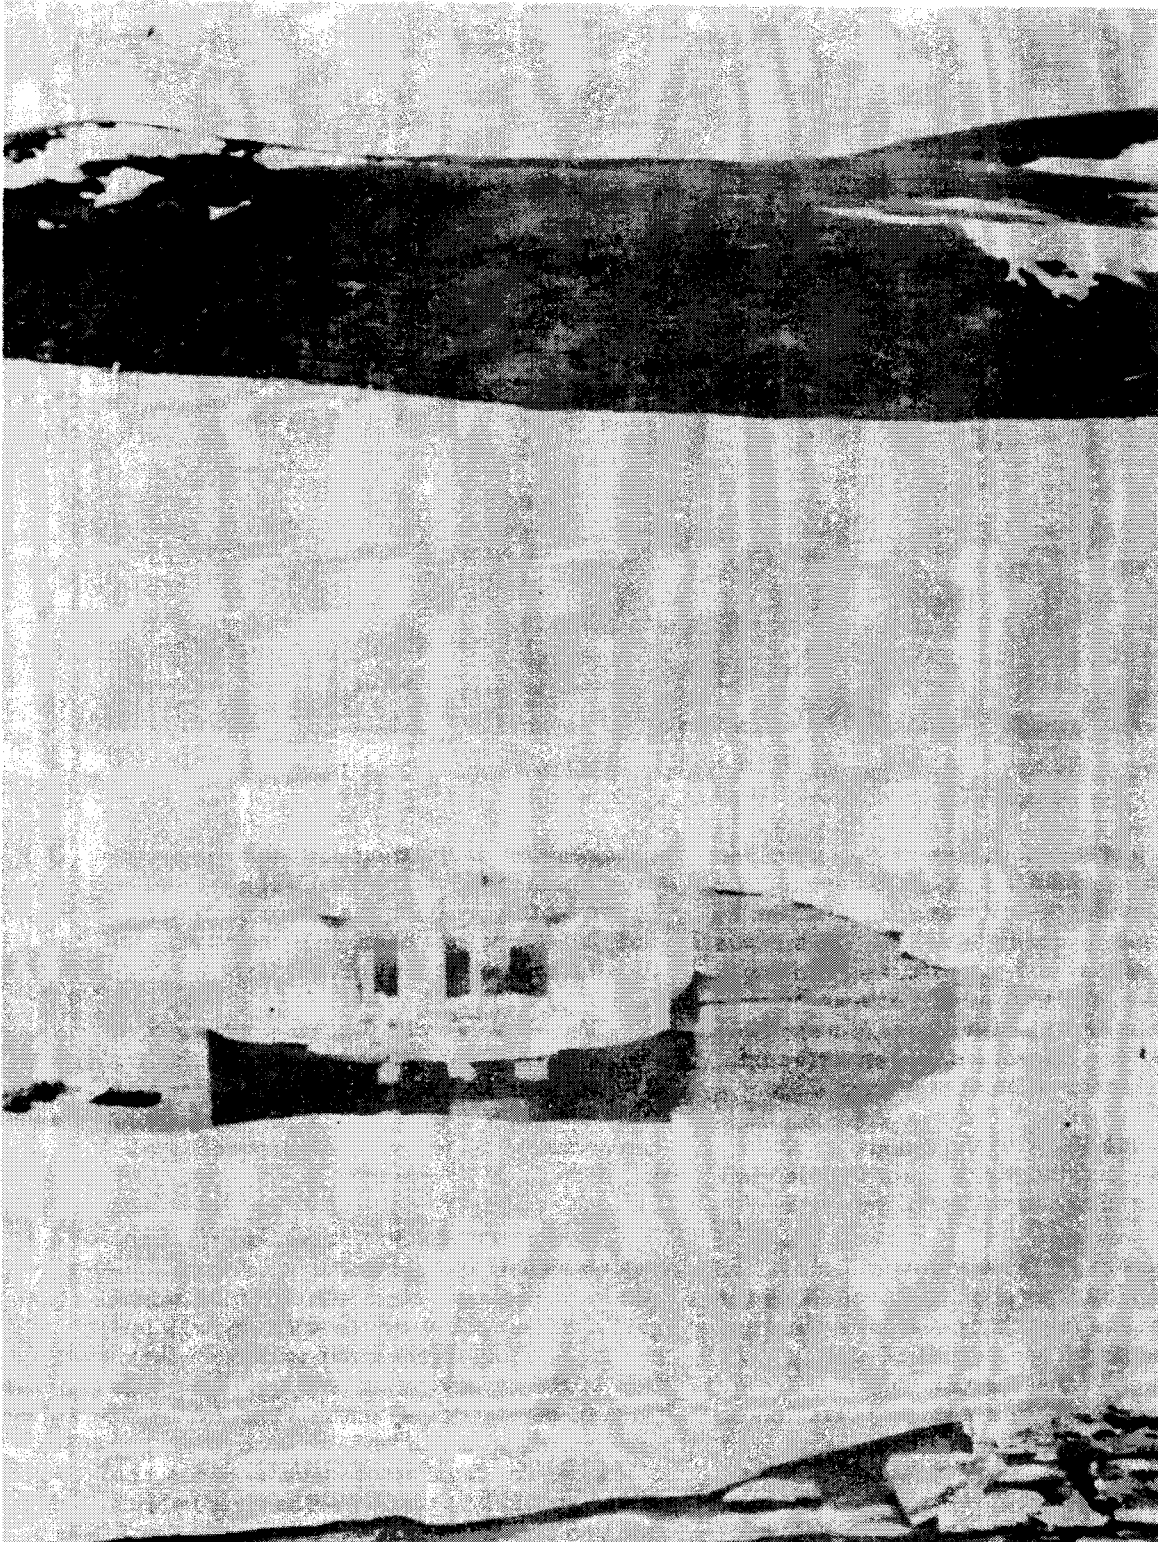
FIGURE 20--On March 27, 1951, the reservoir stood at elevation 2070.0, about 0.2 foot below the submergence point. Ice thickness of 36 inches in February had caused no operating difficulties. Discharge was 2,650 cfs.

voir elevation of 2075, or about 7 feet less than occurred in 1950. On March 27, 1951, the reservoir was at elevation 2070, see figure 20, about 0.2 foot below the submergence point. Again the operation was satisfactory with no visible difficulty despite the fact that on February 15, 1951, the ice in the reservoir was 36 inches thick.

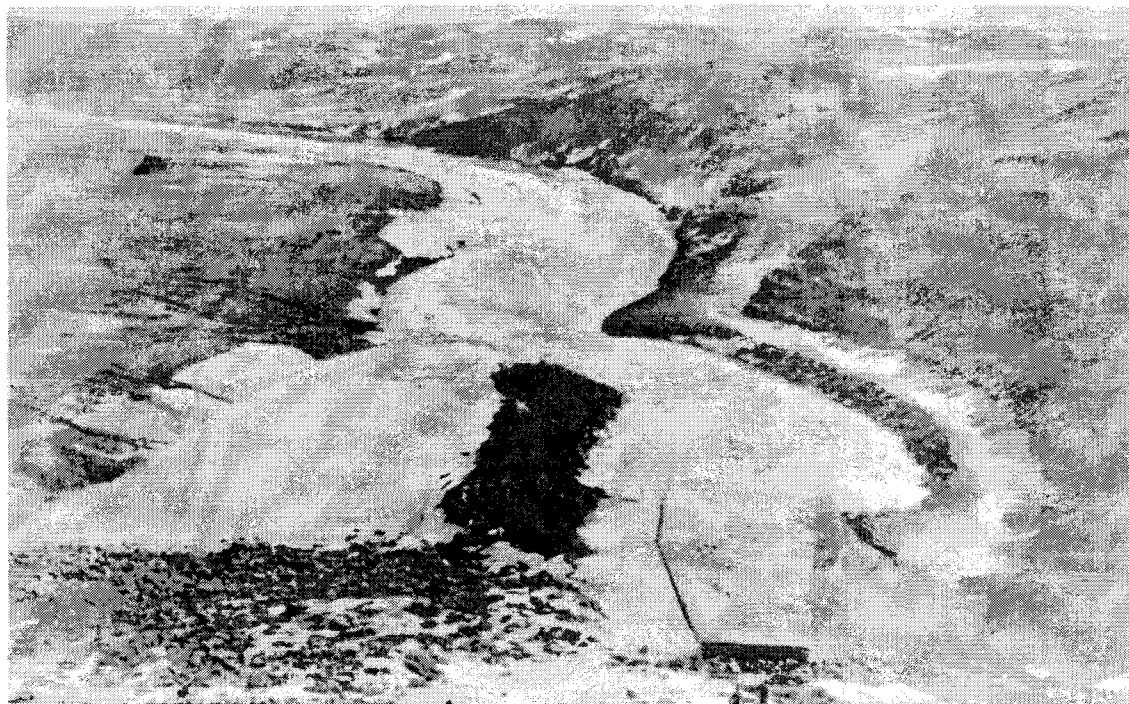
4. Stilling basin performance. --The performance of the stilling basin was satisfactory in every respect and, furthermore, it performed according to the predictions made from the model tests. A general view of the basin and surrounding area is shown in figure 23.

FIGURE 23--Outflow at 3,250 cfs, about 58 percent of capacity. The stilling basin effectively dissipates the energy of the discharge.

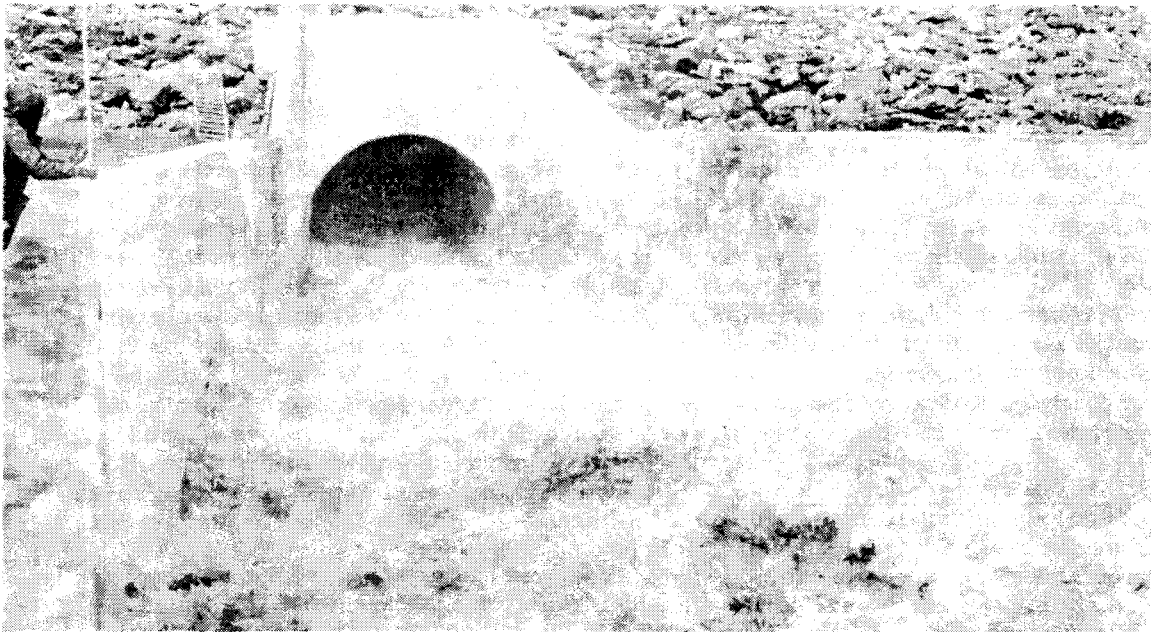
Water leaving the tunnel appeared to be fully aerated and at the approximate depth indicated in the model studies, see figure 24A. The entire basin contained extremely turbulent water, see figure 24B, and was

A--Flow entering the basin was well aerated and well distributed across the basin width.

FIGURE 24--Performance of the stilling basin at a discharge of 3,600 cfs.

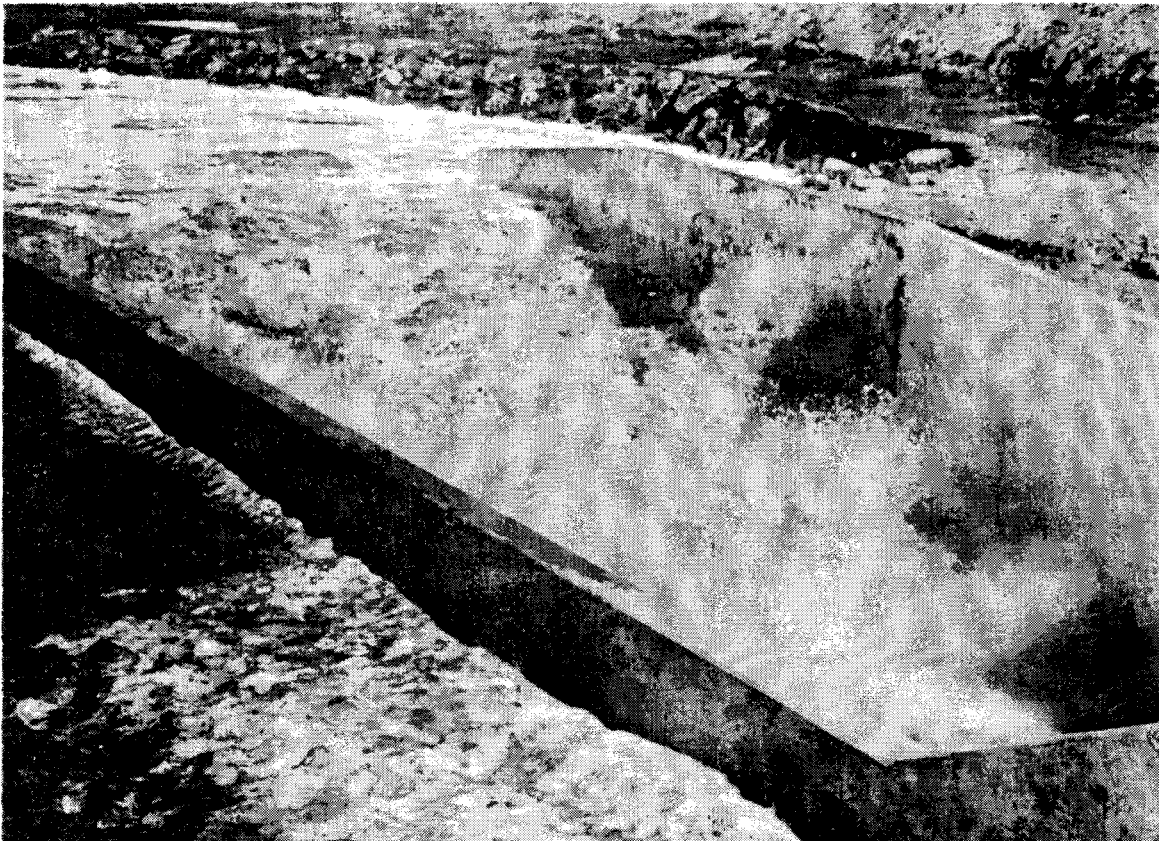
B--Profile of the hydraulic jump showed along the wall. Flow leaving the basin was smooth and uniform.

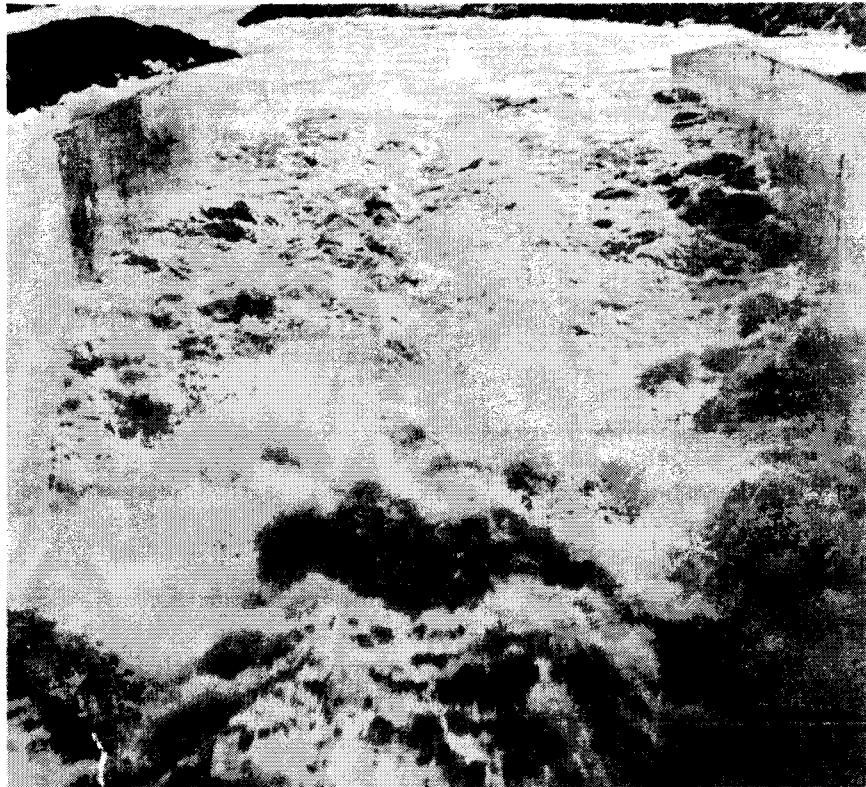
A--Dividing walls, submerged here, were effective in spreading flow to entire basin width.

FIGURE 25--Performance of the stilling basin at Heart Butte Dam in dissipating energy of discharge at a flow of 3,600 cfs.

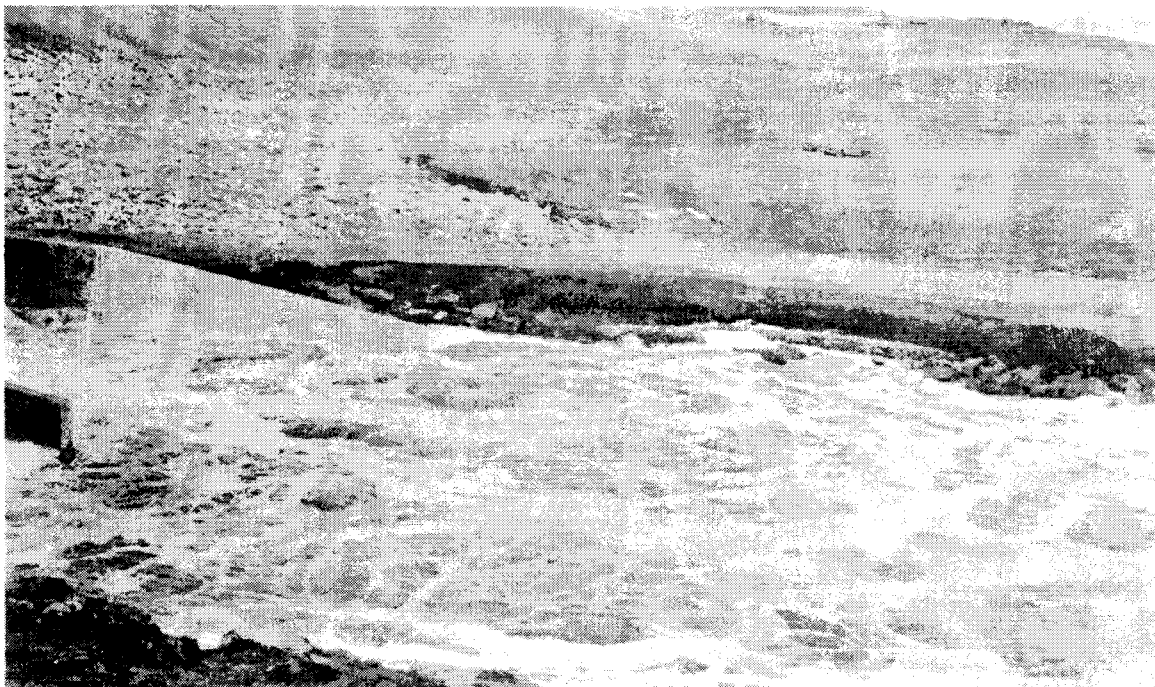
B--Flow leaving the basin had swells and boils, but no choppy waves.

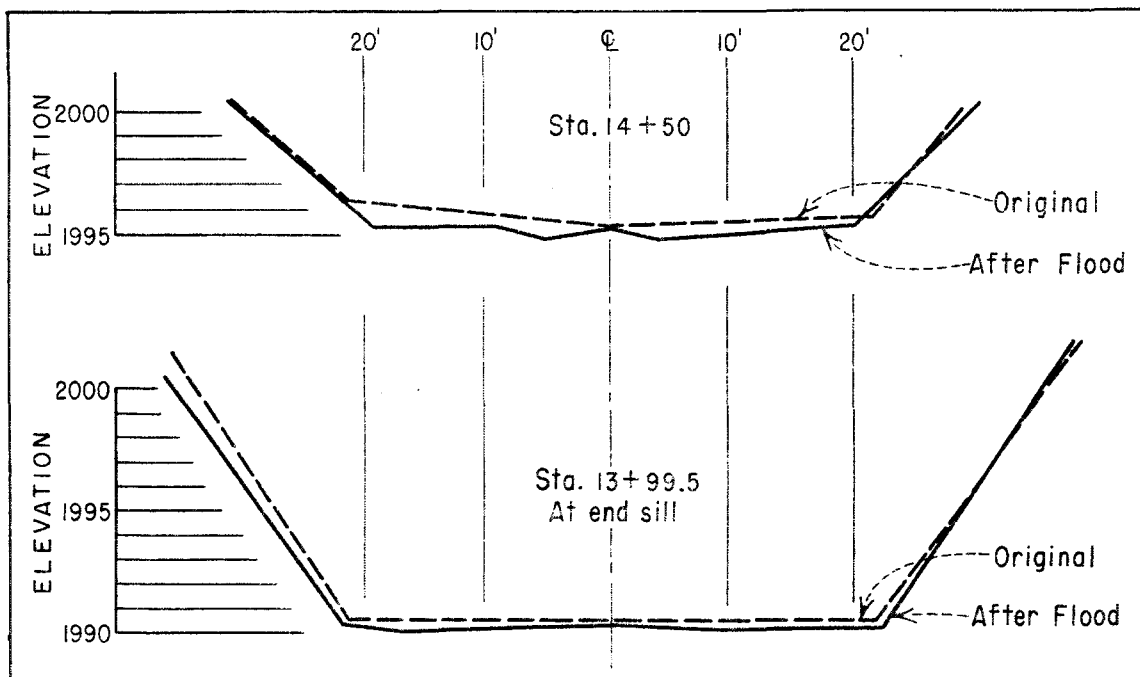
Before the run-off in the spring of 1950, cross sections had been taken in the prototype channel on May 31, 1949. Following the 1950 run-off, cross sections were again taken on June 15, 1950. Cross sections for both dates at a station located just downstream from the end sill and at a station 50 feet downstream from the sill are shown in figure 28. These typical sections show the maximum erosion depth to be less than 12 inches. Close to the end sill there is no significant erosion. Using all the cross sections taken, see figures 28 and 29, calculations indicated that less than 20 cubic yards of material was

FIGURE 28--Comparative cross sections show that there was little erosion in the river channel below the stilling basin during the 1950 flood.

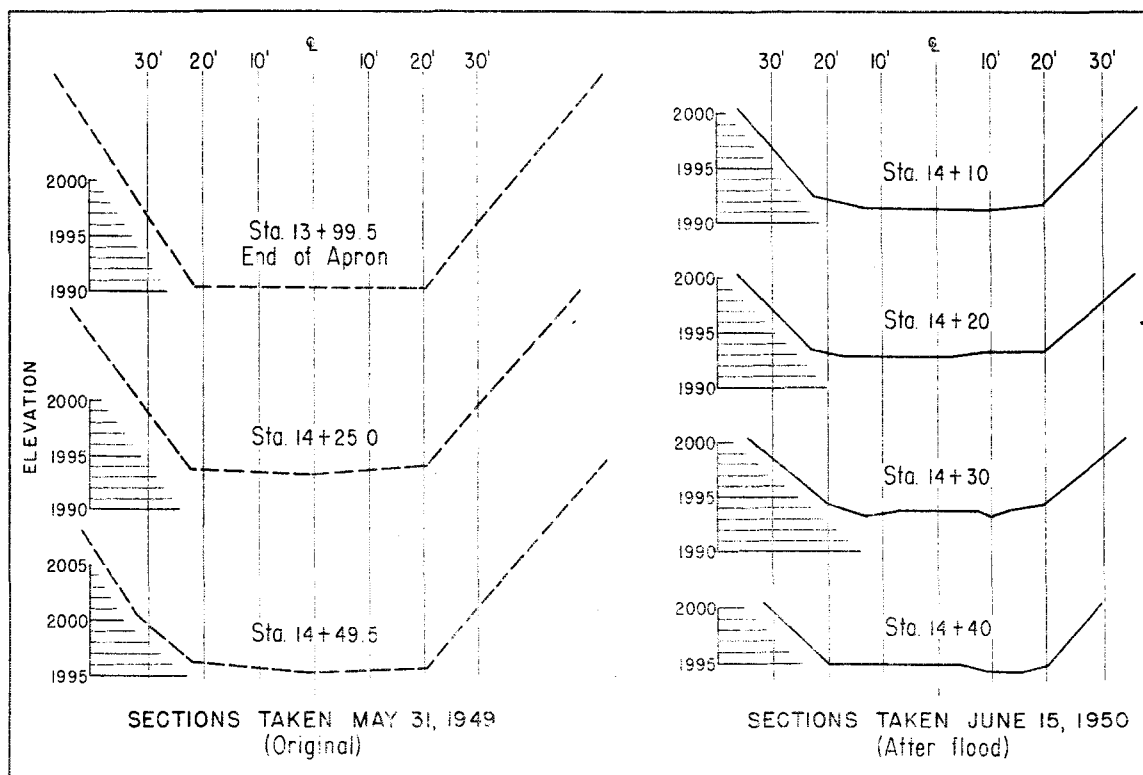
FIGURE 29--Detail cross sections showing before and after conditions in river channel below the stilling basin.

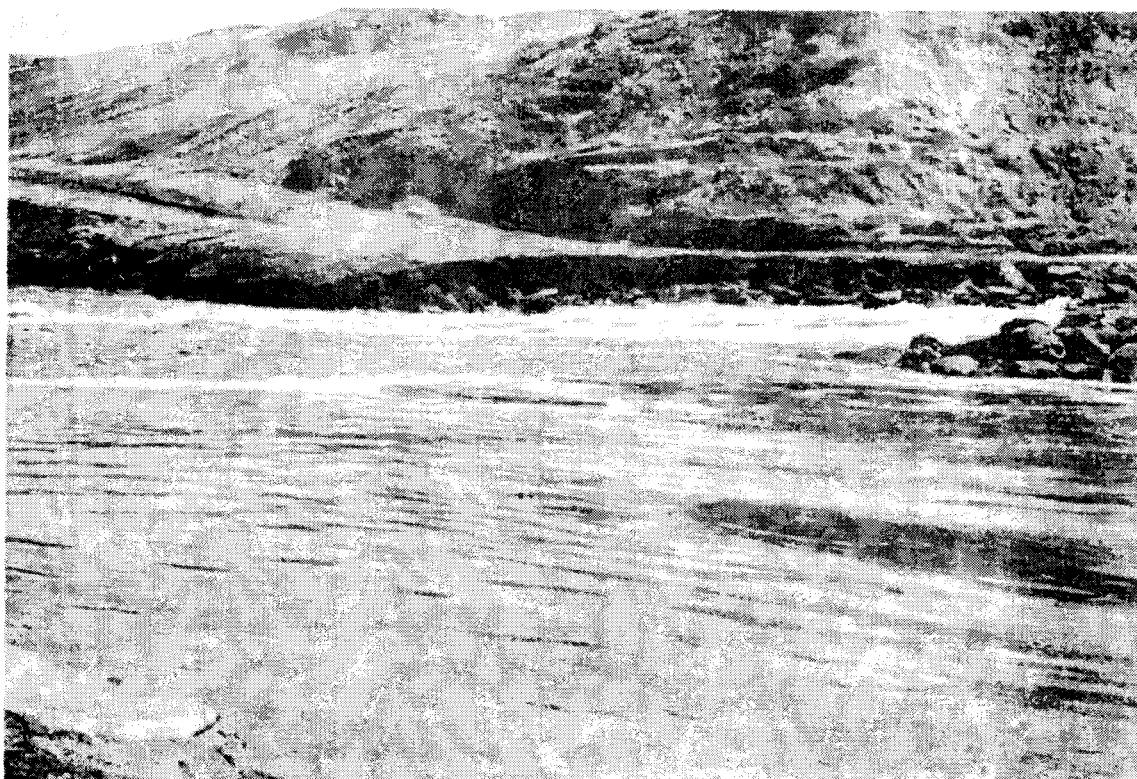
During the prototype operation it was readily apparent that the tail-water elevation in the river was considerably lower than that in the excavated channel. Water entering the river from the channel had a steep surface slope and a much higher velocity than anticipated, see figure 32A. Observations, however, were not sufficient to establish whether the tail water in the channel was too high or that in the river too low. Levels were run to determine the tail-water elevation at four separated points for five different discharges. The location of these points, together with the tail-water elevation and discharge, is shown in figure 31. These values are plotted below the tail-water curve used in the model tests. These data show the computed tail-water curve to be 2.3 feet higher at 1,000 second feet and 4.1 feet higher at 3,600 second feet than the actual measured points in the Heart River. Tail-water elevations measured in the excavated channel more nearly coincided with the computed curve, but at 3,600 second feet the elevation at Point C, figure 31, taken in a quiet area adjacent to the wing wall at the end of the apron, was 1 foot below the computed curve. Elevations obtained from water-surface profiles taken along the basin center line agreed with the computed curve, but only because they in-

A--The 4-foot difference in elevation between the flow in the excavated and natural channels at 3,700 cfs accelerated the discharge.

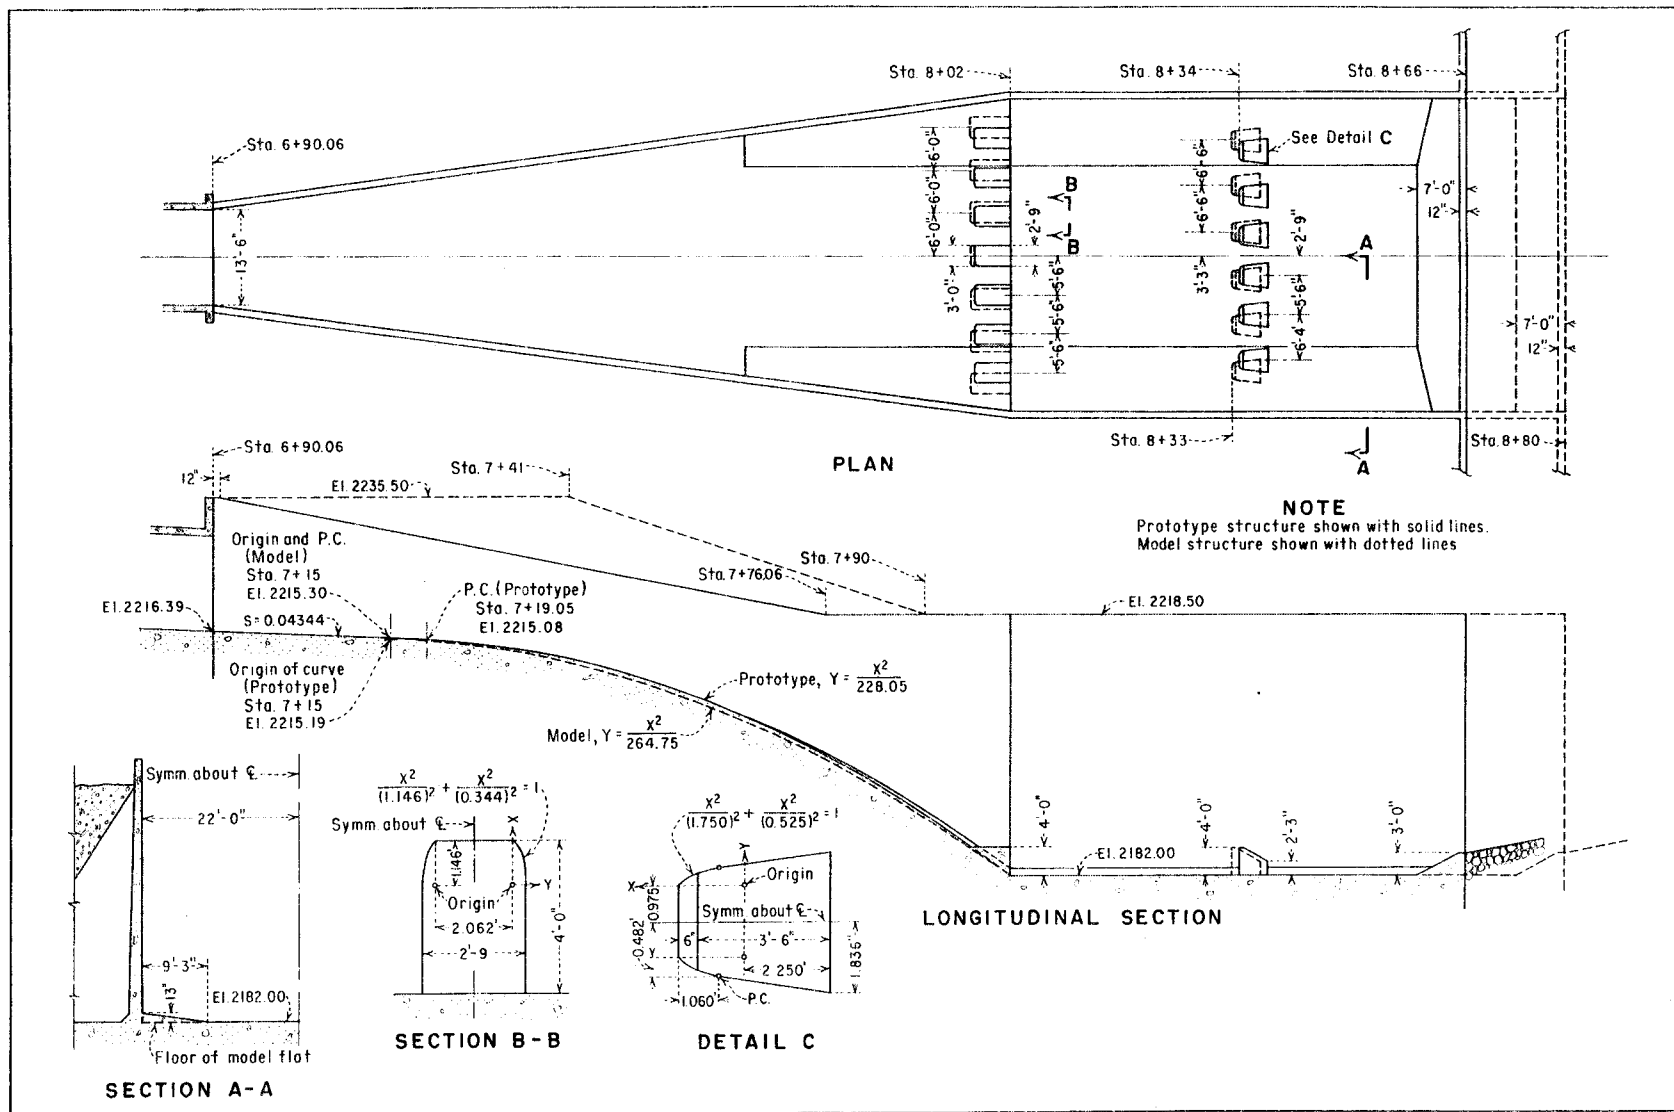
FIGURE 39--Stilling basin for Shadehill spillway, showing variation between model and prototype.

8. Stilling basin performance. --During the hydraulic model tests, a basin was developed and recommended for field construction that was believed to be the minimum basin possible for good performance at maximum discharge. To reduce the cost of the basin it was proposed, however, that a basin 14 feet shorter than the recommended be tested. This shorter basin was not as effective as the longer basin in providing smooth flow in the channel, but it was deemed that the shorter basin would provide adequate energy dissipation to prevent channel bottom erosion even though the waves and surface disturbances would be more evident. The shorter basin was adopted after the model tests had been completed. During preparation of the construction drawings it became necessary to modify the upper end of the basin somewhat and consequently the basin constructed in the field was not identical to the one model-tested. Figure 39 shows model and prototype basins and indicates the differences in dimensions.

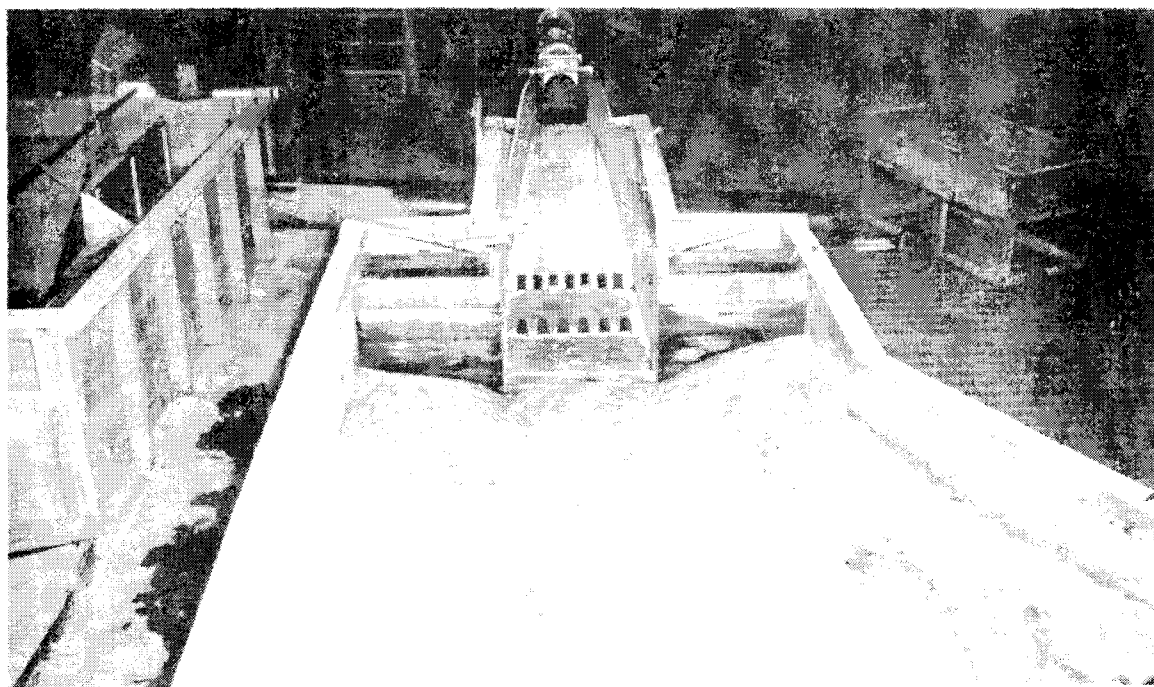
B--Erosion after 1-hour model test.

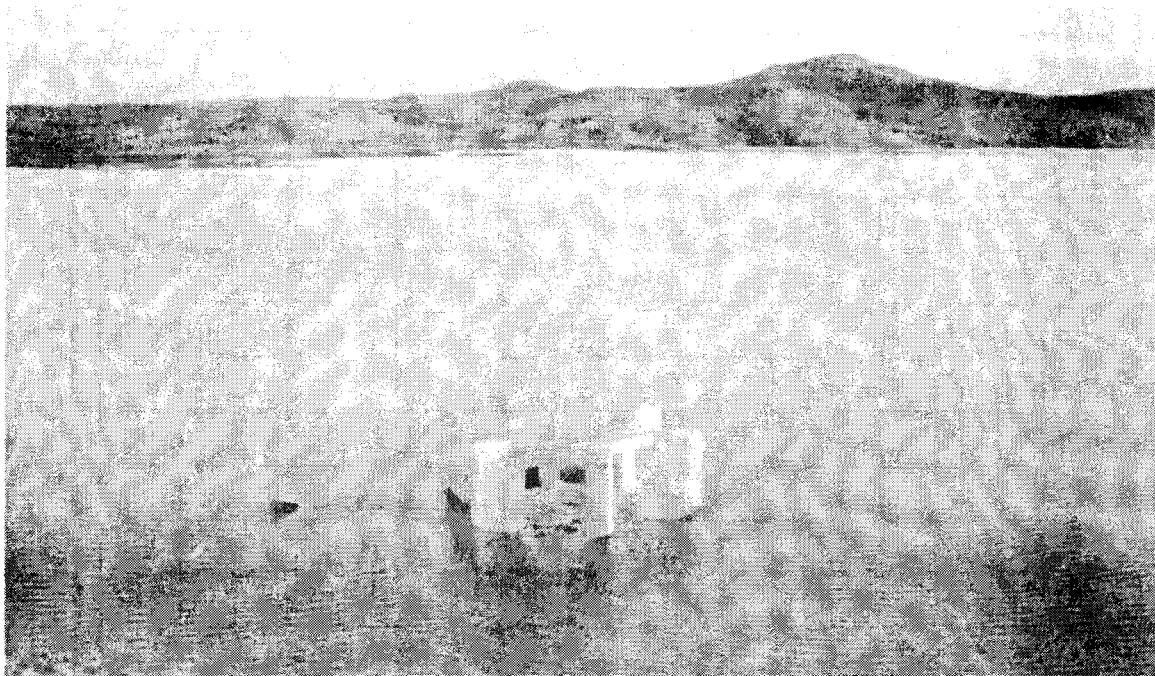
A--Submerged flow at headwater elevation 2277.2, about 0.3 foot above free discharge point. About 7:00 p. m., May 1, 1952.

way taken just before dark on May 1. The headwater elevation was 2277.2 or about 0.3 foot above the free discharge point. The flow was smooth with no apparent pulsation, even though the "mushroom" had started to recede in the shaft. Early the next morning another photograph, figure 46B, was taken with headwater at elevation 2276.7, or about 0.2 foot below the free discharge point. The flow was free with no column of water visible in the shaft. The three elevations discussed above are plotted on figure 44 as Points A, B, and C, and indicate that the prototype performance was exactly as predicted by the model.

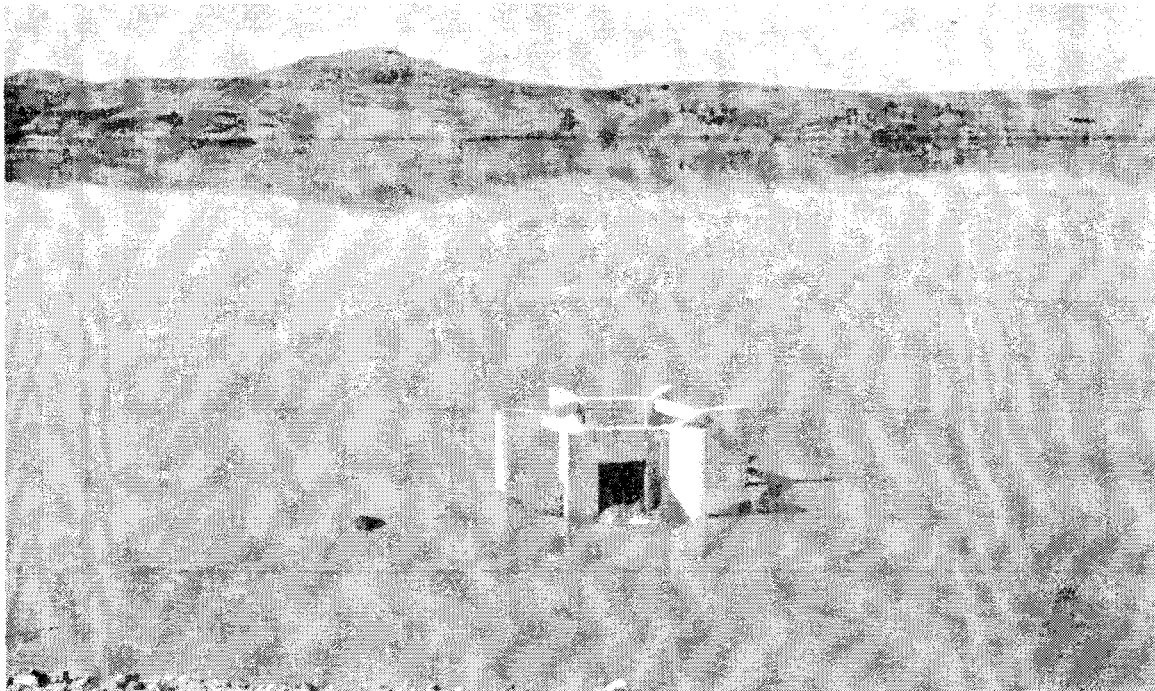
B--Discharge changed to free flow during the night. At headwater elevation 2276.7, it is about 0.2 foot below free discharge point.

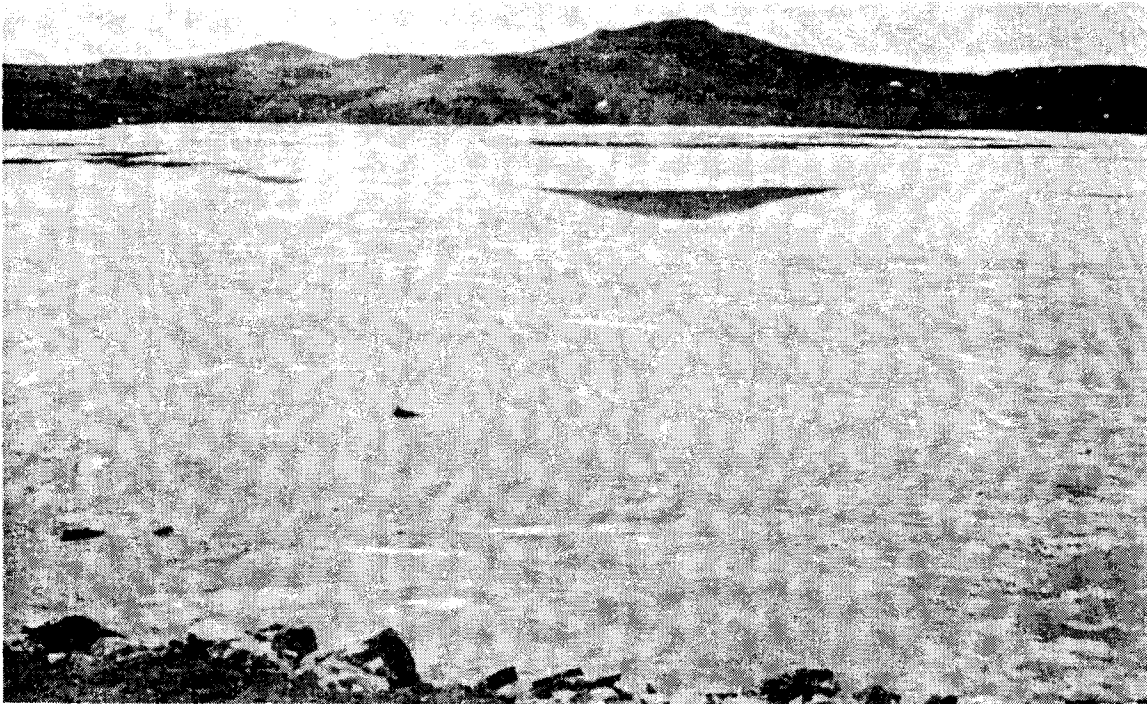
A--Spillway area covered with decaying sheet ice about 4 inches thick.
Morning glory is to right of tilted oil drum.

decayed sheet ice about 4 to 6 inches thick (figure 48A). In the vicinity of the spillway the ice appeared to be in continual vertical motion. Ice particles seemed to be rising and falling and to be causing a tinkling sound which could be heard plainly on top of the dam. It is believed that the partially decayed ice was being subjected to compressive forces by the converging flow, causing the ice to shatter and splinter. Other action over the spillway was so mild, however, that it was difficult to find the spillway location from the appearance of the reservoir surface. On April 18 the reservoir was 0.2 foot lower and a fairly large area near the spillway was free of ice. A vortex was evident at all times, see figure 48B. The vortex was stable and did not change its location laterally more than a few feet during the entire day. The model vortex was less stable in this respect, being in lateral motion almost continuously. This lateral movement of the vortex in the

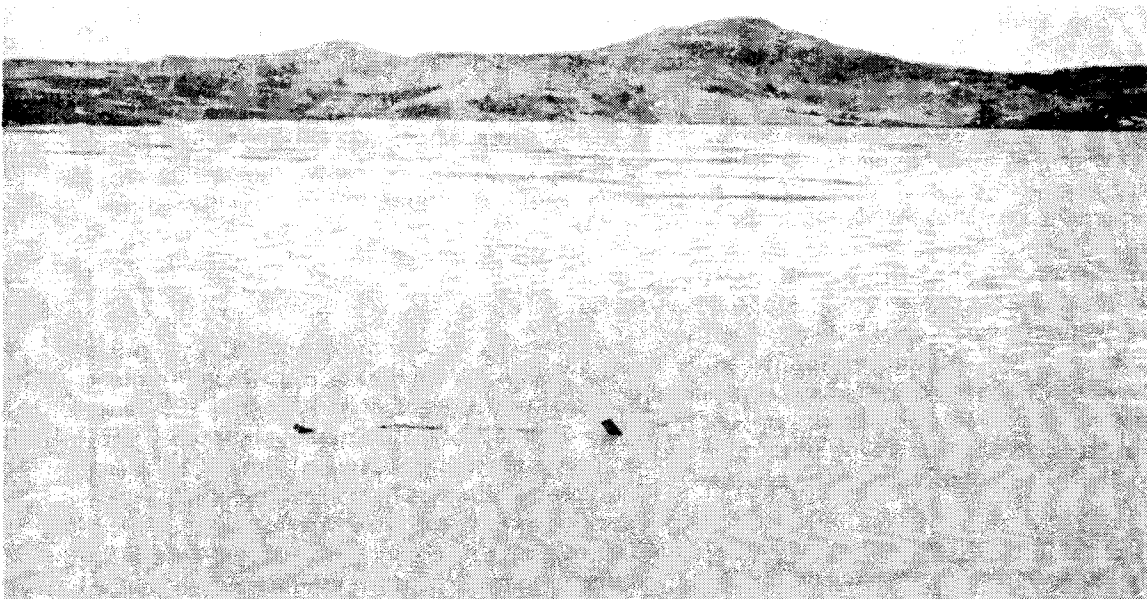
B--Sheet ice was broken up and discharged through vortex, keeping area
around spillway free of ice.

Occasionally an ice sheet drifted over the prototype vortex opening, causing the vortex action to stop momentarily. But after a few seconds, the ice sheet would disintegrate and fairly large pieces of ice would be carried down by the vortex. The vortex resumed its normal action when the entire sheet had been broken up and discharged through the spillway.

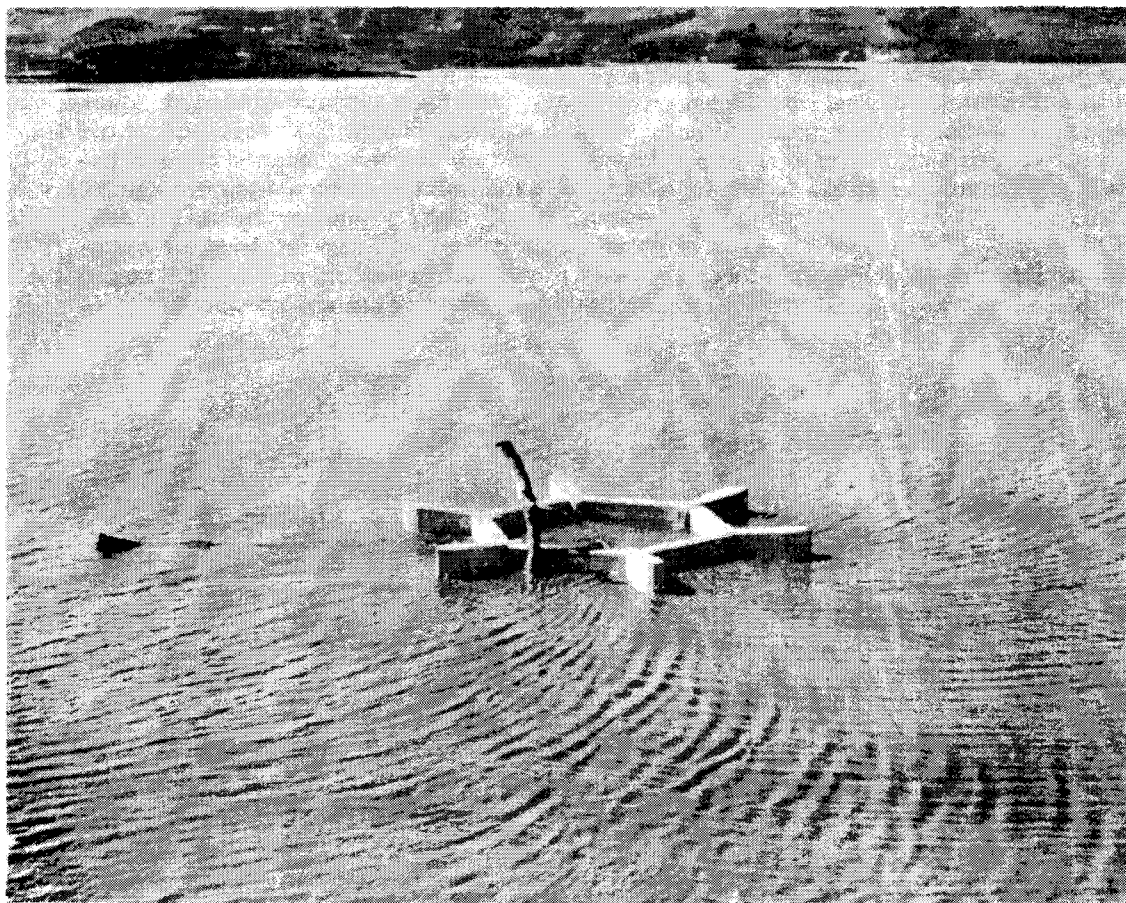
FIGURE 49--At headwater elevations above this point, elevation 2284.9, vortex action was continuous. The vortex is partially hidden by a pier strut.
